The Church of Dayr Abu Matta and its Associated Structures: an overview of four seasons of excavation

Gillian E. Bowen

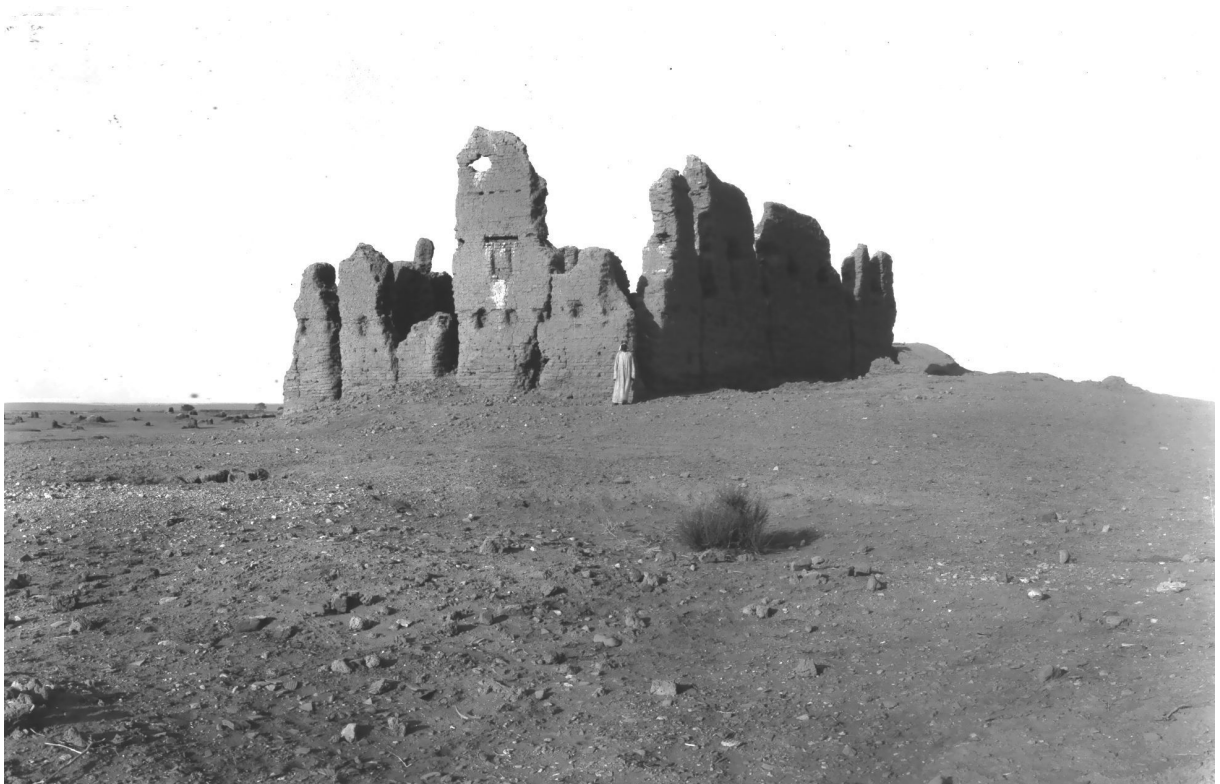
*Plate 1 The church in 1908 showing the east and north walls looking south-west;
photo by H. Winlock (1908) © Metropolitan Museum of Art, New York.*

the visible remains (Plates 1 and 2). It is apparent from his description that the church was merely a shell and that, with the exception of the sanctuary, none of the internal architecture remained or was at least visible. In Winlock's day, the north and east exterior walls were preserved, in part, to a height of at least six metres but a fourteen-metre section of the south wall had collapsed.

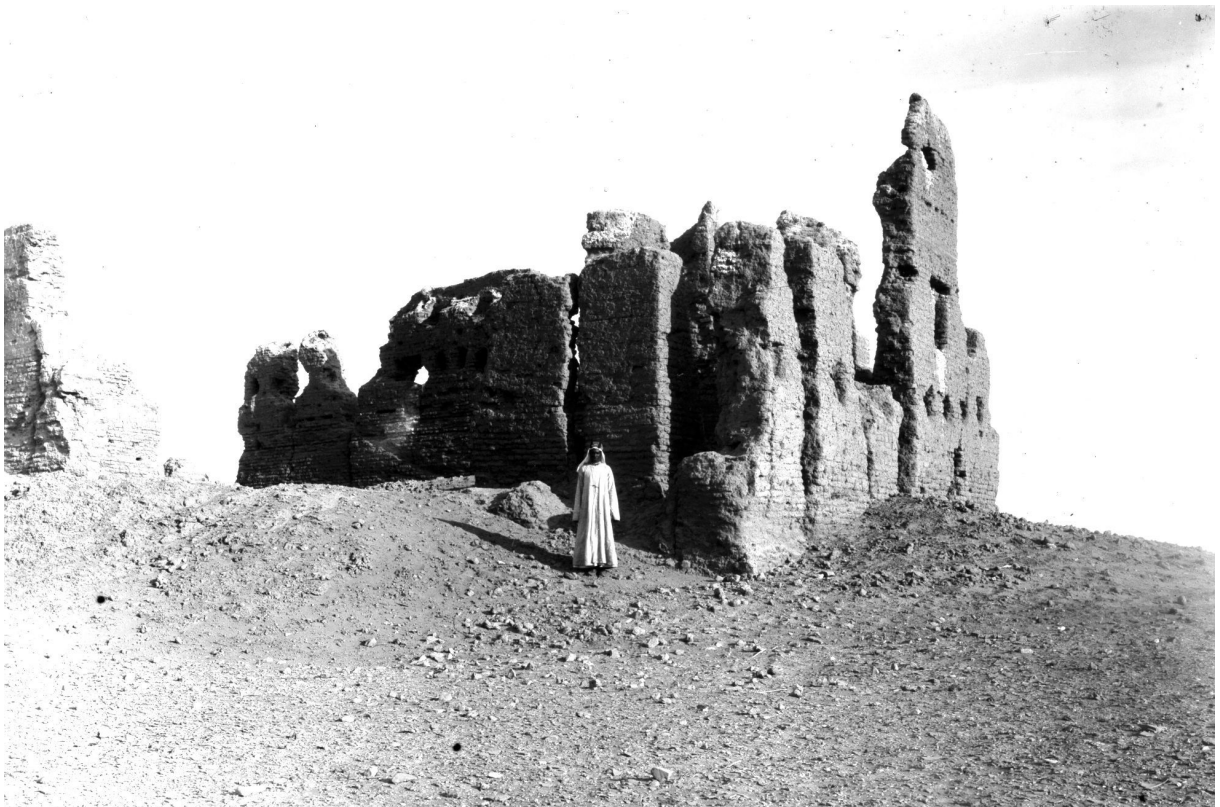
*Plate 2 The church in 1908 showing the window in the east wall looking north-west;
photo by H. Winlock (1908) © Metropolitan Museum of Art, New York.*

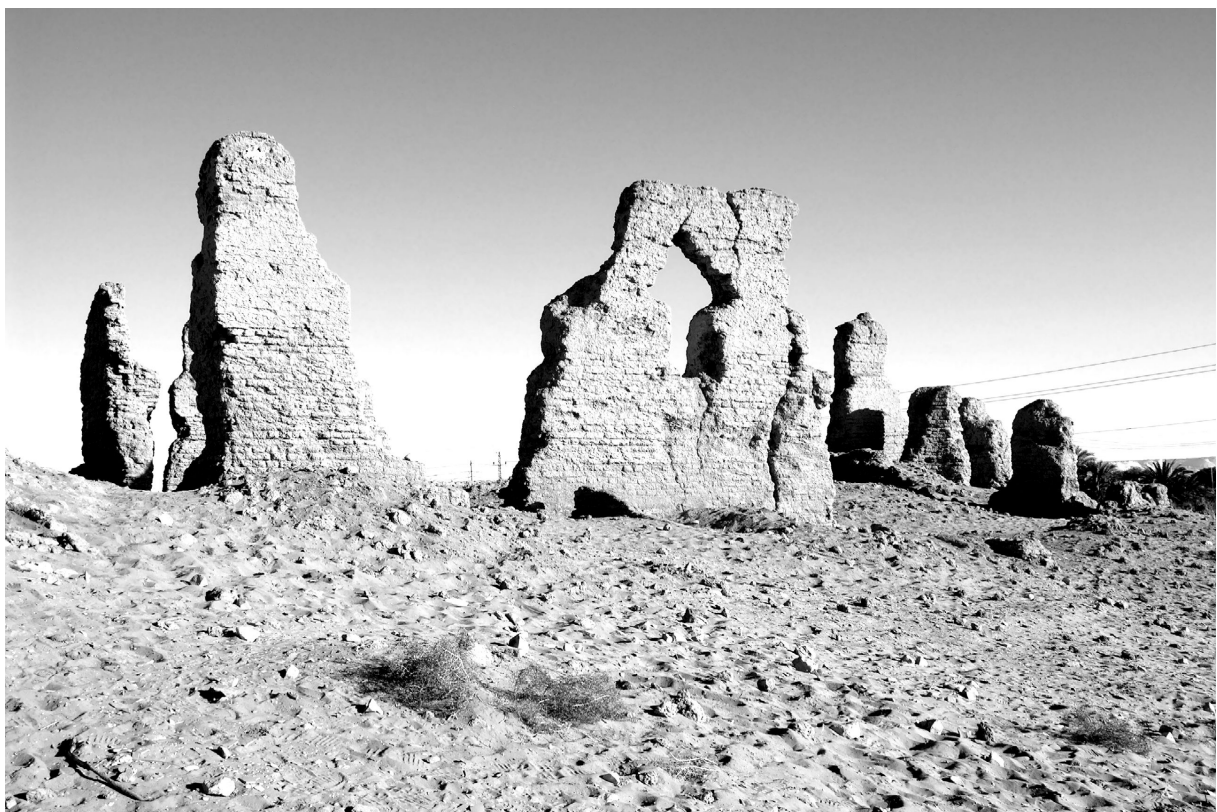
Plate 4 The extant remains of the church in 2008 showing the remaining window looking north; © C. A. Hope.

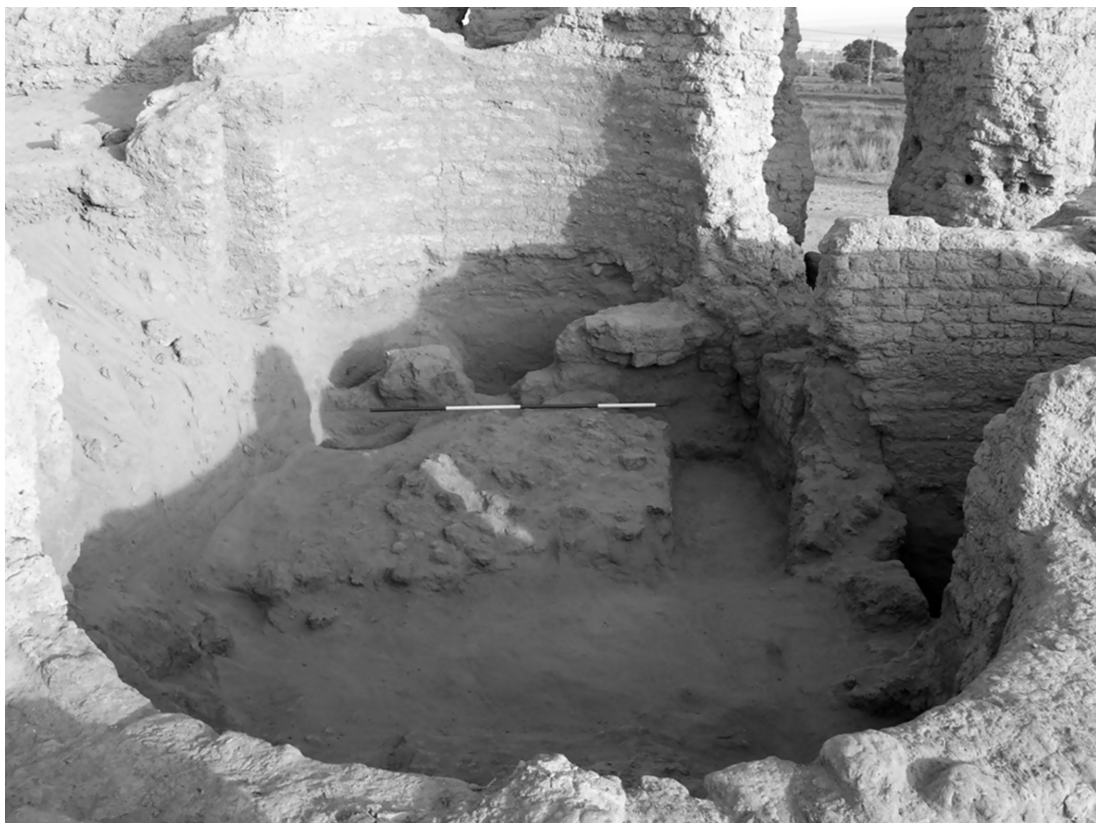
Plate 6 Trench 6, the sanctuary showing the low walls beneath the east and north apses looking north;
© C. A. Hope.

The sanctuary occupies an area 6 metres north-south by 5.70 metres east-west and comprises three semi-circular apses, with a central space of 3.5 square metres (Plate 6). It is flanked on the north and south by two narrow L-shaped rooms, neither of which gives access to the sanctuary and therefore the only point of entry was

wall of the apse. The early wall beneath the entrance to the east apse is broken and dislodged; it appears to abut the east-west wall in Space 1 on the north and continues beyond the south wall of the east apse (Plates 6 and 7).

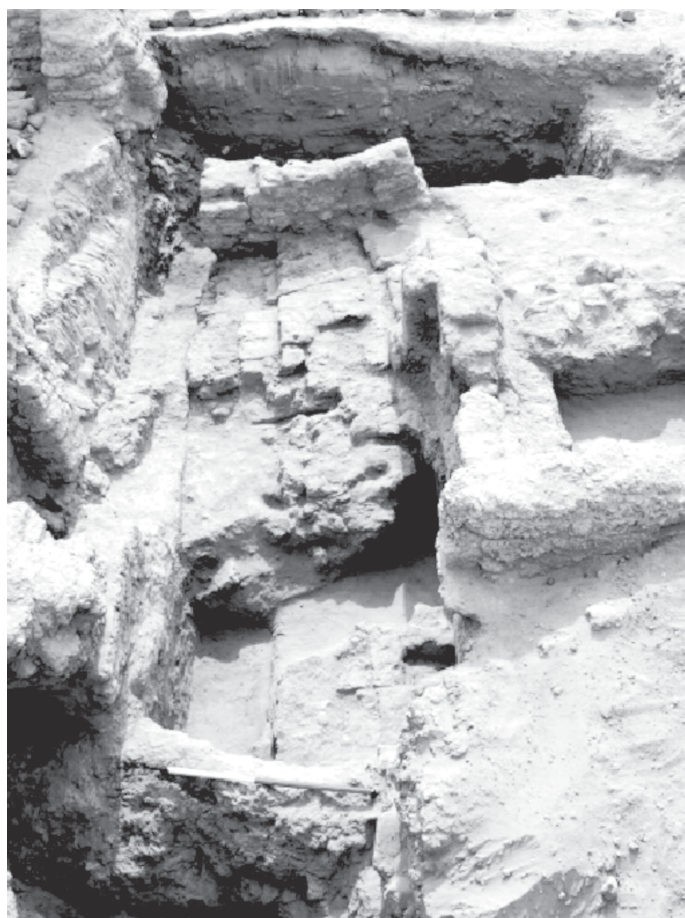
Plate 8 Trenches 8 and 10 showing the early structures beneath the nave with the paved floor in the centre looking south; © C. A. Hope.

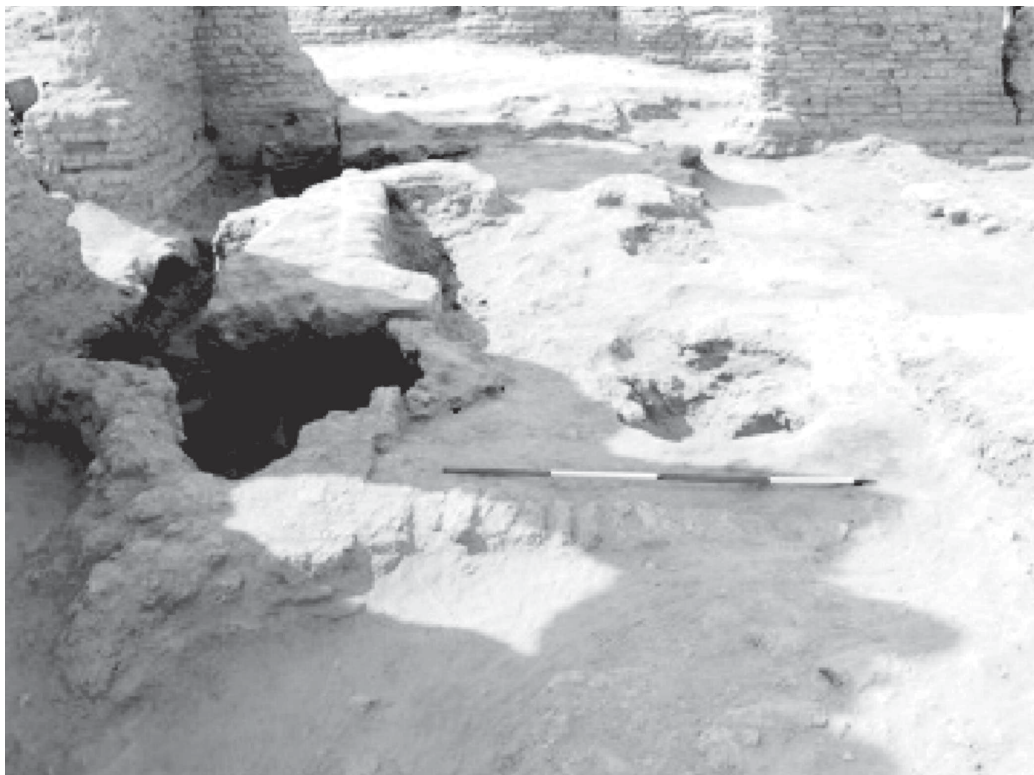
Plate 9 Trench 4, the west nave showing the south-west corner of the church, the remaining internal architecture, cuts for the graves, the late north-south wall in the foreground, the entranceway to the church and the wall of the west building at the top looking west; © C. A. Hope.

the mud floor into the sand on which the church is built (Plate 9). Only one undisturbed burial was found but numerous disarticulated human bones were encountered in these pits and amongst the debris throughout the church. The body is that of an infant buried in a shallow grave. The infant had been buried in a hooded linen garment, edged with a tapestry band (Livingstone in Bowen 2009, 14–15, Plate 8). The skeletal remains of two adults were found in graves parallel to the south wall of the church; both had apparently been wrapped in red cloth, much of which lay within the same vicinity as the bodies. Tosha Dupras, who is studying the physical remains, reports that the injuries on one of these bodies indicate that the woman met with an extremely violent death. Because of the disturbance in this part of the church it is not possible to determine the number of graves but they presumably represent a final phase of activity after the church was abandoned.

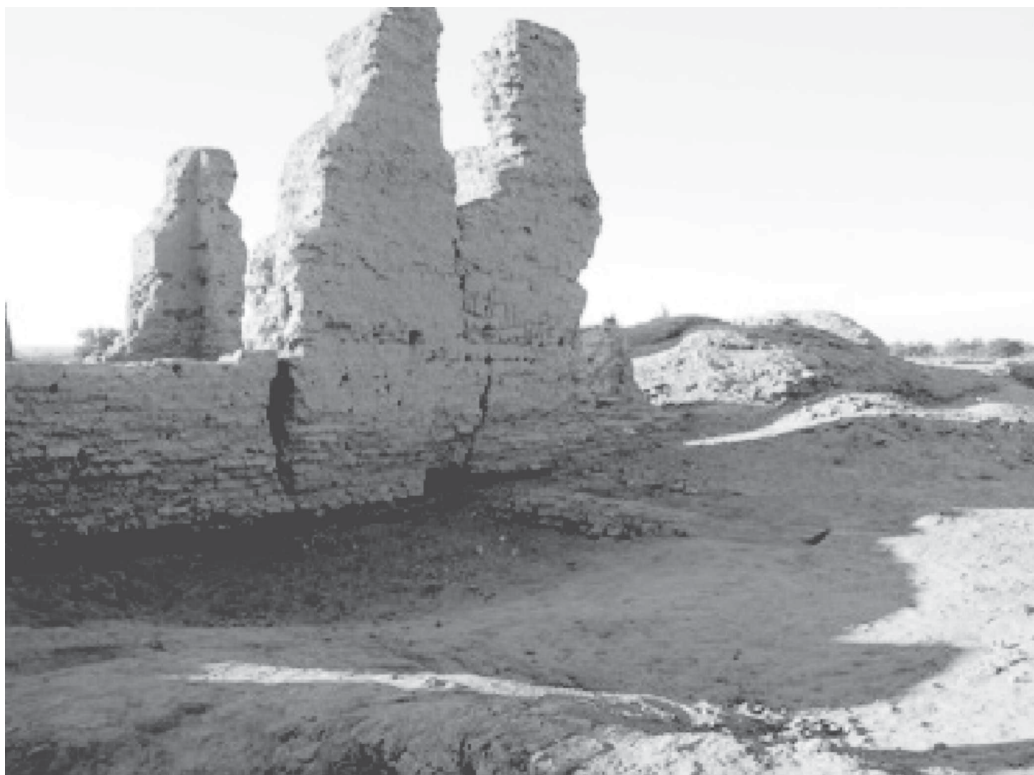
Plate 10 The north-east corner of the church showing the tops of the north structures in the foreground and the north-east corner of the west buildings in the upper right looking south-west; © C. A. Hope.

An area 20 metres east-west by between 4 and 6 metres north-south has been excavated to the immediate north of the church commencing four metres east of the north-west corner and working progressively east. This work has spanned four excavation seasons: 1979, 2007/8, 2010 and 2011. Only the tops of walls were visible in this area and they can be traced continuing in a northerly direction down the mound at which point they disappear beneath an unsealed road used by the local farmers. There is an irrigation ditch and cultivation immediately north of the road. In the 2007/8 field season, the tops of walls were brushed in order to draw a plan, which has been added to in subsequent seasons (Plate 10).

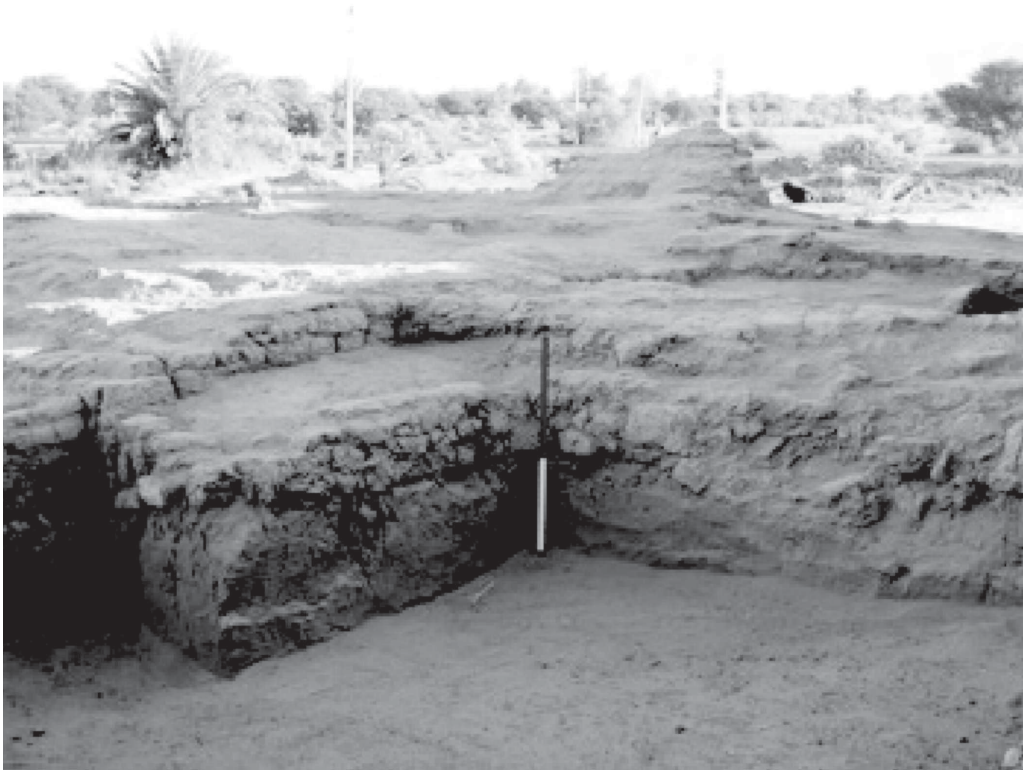
*Plate 11 Trench 1 showing a late wall in the centre-east of the rectangular structure looking north-east;
© C. A. Hope.*

The area is dominated by the remains of a rectangular building 11.25 x 7.75 metres, three quarters of which has been excavated (Trenches 1 and 2).⁷ Two major building phases were identified within this structure. The earlier phase is represented by a series of walls built on an oblique angle; all walls of this phase are laid directly onto sand. The rectangular structure was then built and underwent a series of modifications (Plate 11). The only entrance-way to be identified is located in the south-eastern corner of the building; it opens into a narrow irregularly-shaped room with a maximum width of 1.3 metres. This room is bordered on the west by a curving north-south wall which belongs to the first building phase. At some point a circular feature, probably a storage bin, was set into the floor of the narrow room blocking access to the north (Plate 12); only its brick base remains. All north-south walls were later cut back in the south to build the north wall of the church, which post-dates the construction of the rectangular building. Following the abandonment of the structure, the area was used as a cemetery and pit graves were cut through the laid mud brick floor. Four graves were found in Trench 1 (see above). Pit graves were also found in Trench 2 but all had been robbed. Because of the damage to the floor it was impossible to determine the exact number of graves in this part of the structure; two, however, were cut into the north wall of the church, confirming their relative chronology.

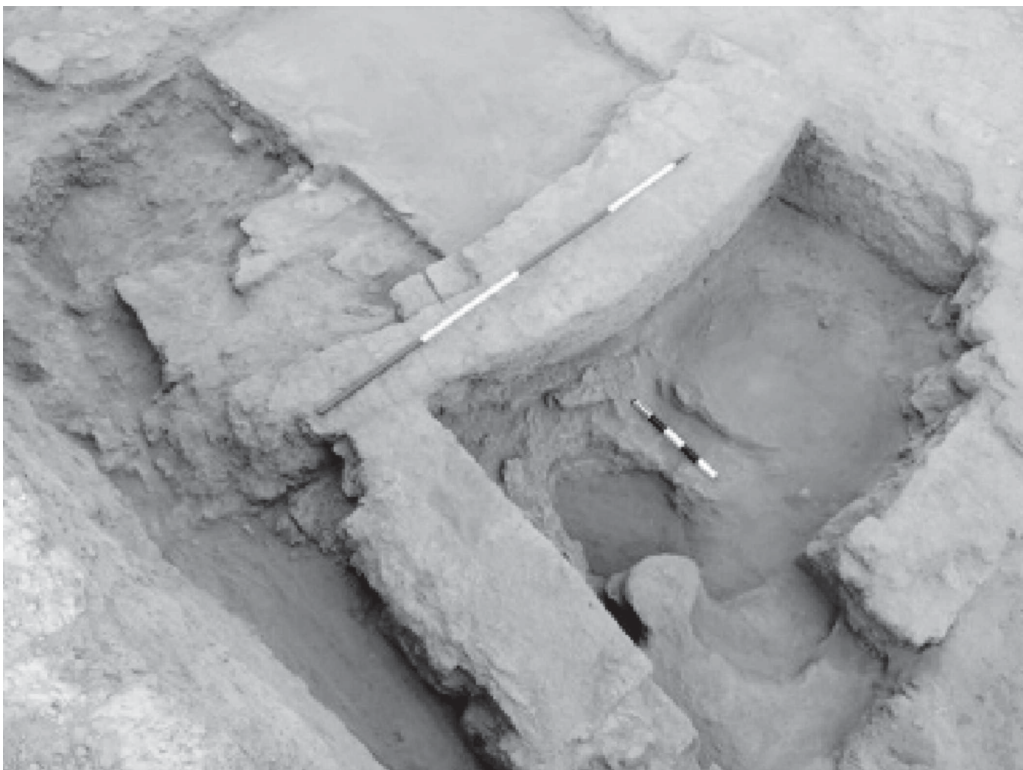
Plate 12 Trench 2, showing the small room with the outline of the circular feature in the upper right and the doorway in the lower right, the north wall of the church in the lower left and the remains of a stratified floor surface at the top looking north-west; © C. A. Hope.

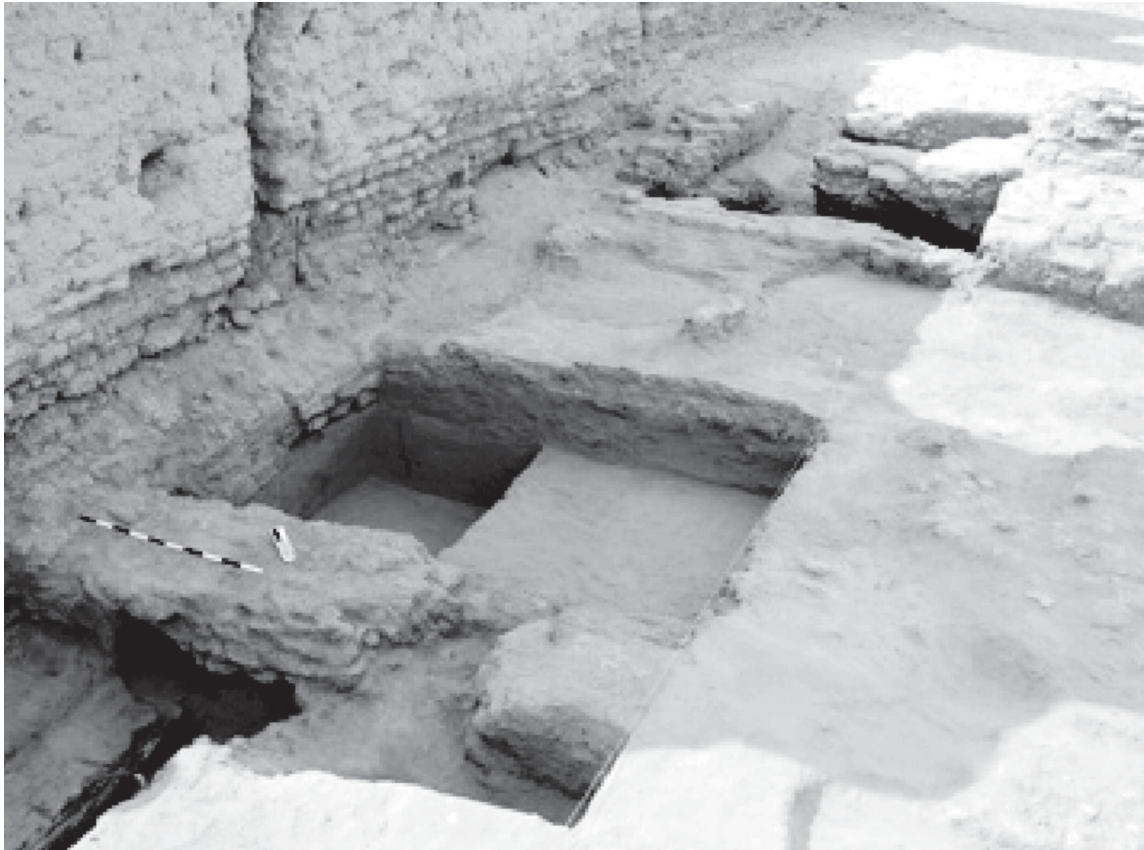
Plate 13 Trenches 9 and 14, showing the north wall of the church on the left and the low wall over which it was built with a grave pit in the lower left and against the church wall looking south-west; © C. A. Hope.

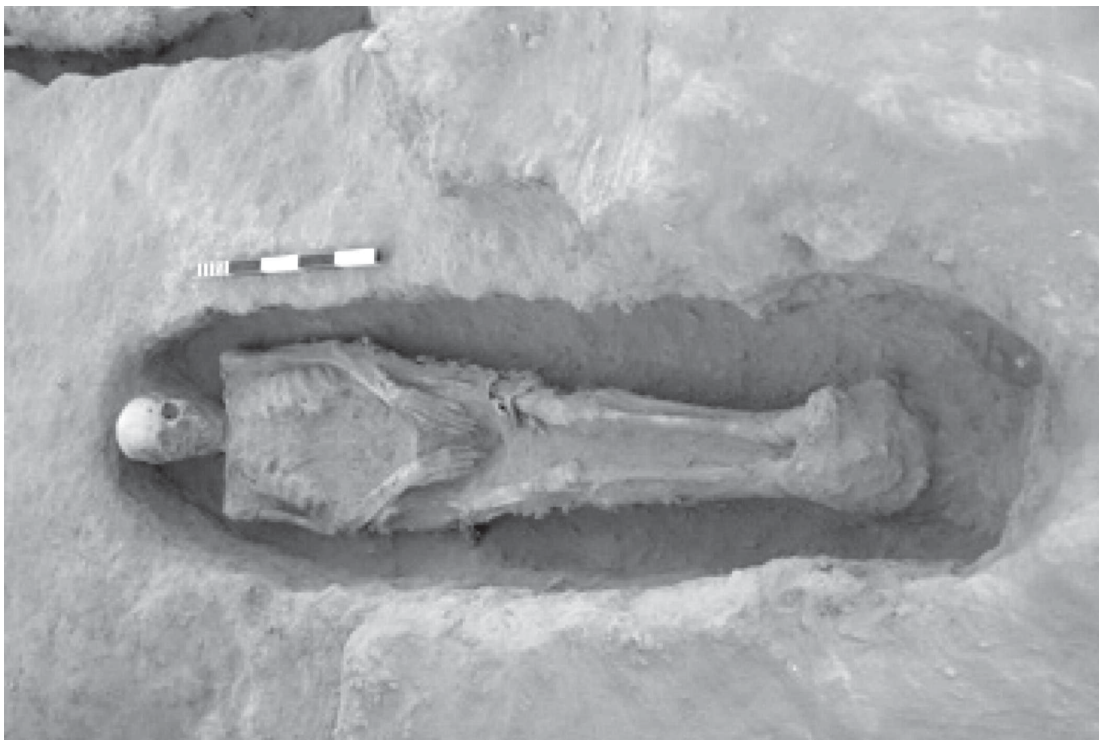
Plate 14 Trench 9, showing one of the Christian burials with the edge of a second grave in the upper left looking north; © C. A. Hope.

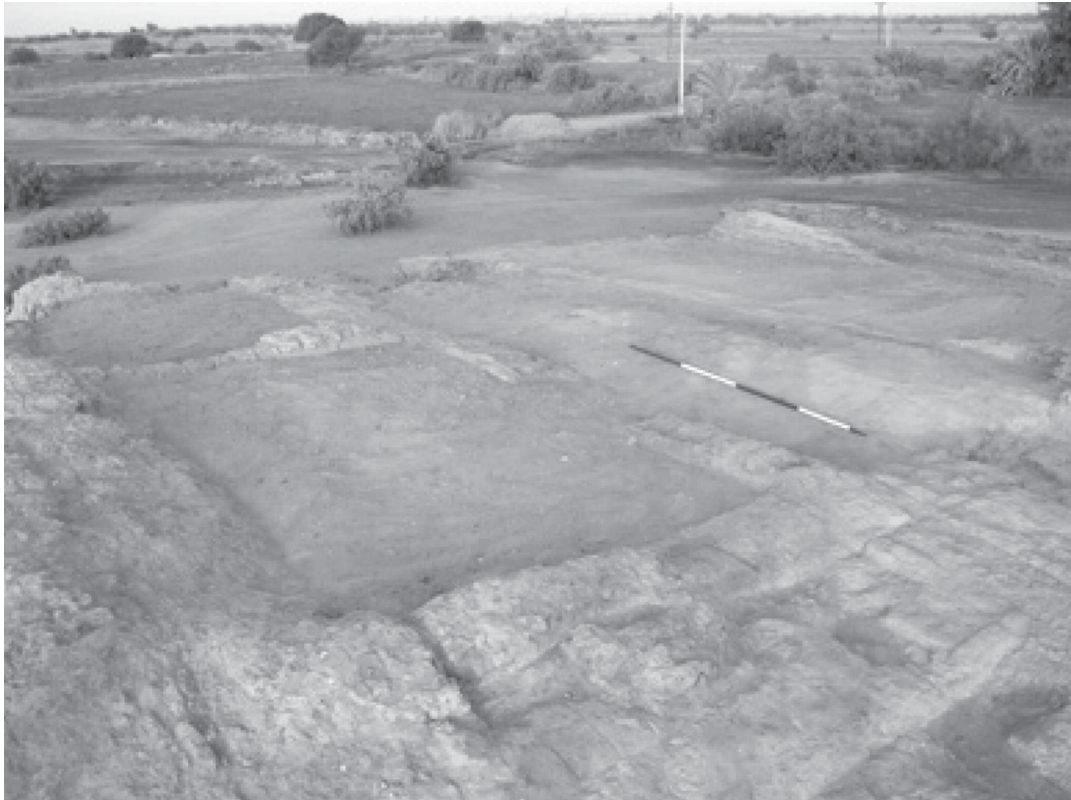
Plate 15 The west building showing the tower and the west walls of the eastern extension prior to excavation looking north-west; © C. A. Hope.

The exterior walls on the northern part of the structure are 1.6 metres wide, well defined and easily accessible but those in the southern part could not be distinguished because of a series of modifications that had been undertaken with walls built against walls. We chose to excavate the north-west and the south-east rooms (Trenches 6 and 10) to expose the foundations of the structure in the north and to try to locate the outer walls in the south, and the corridor (Trenches 11 and 12) to determine the relationship between the tower and the eastern extension (Plate 15).

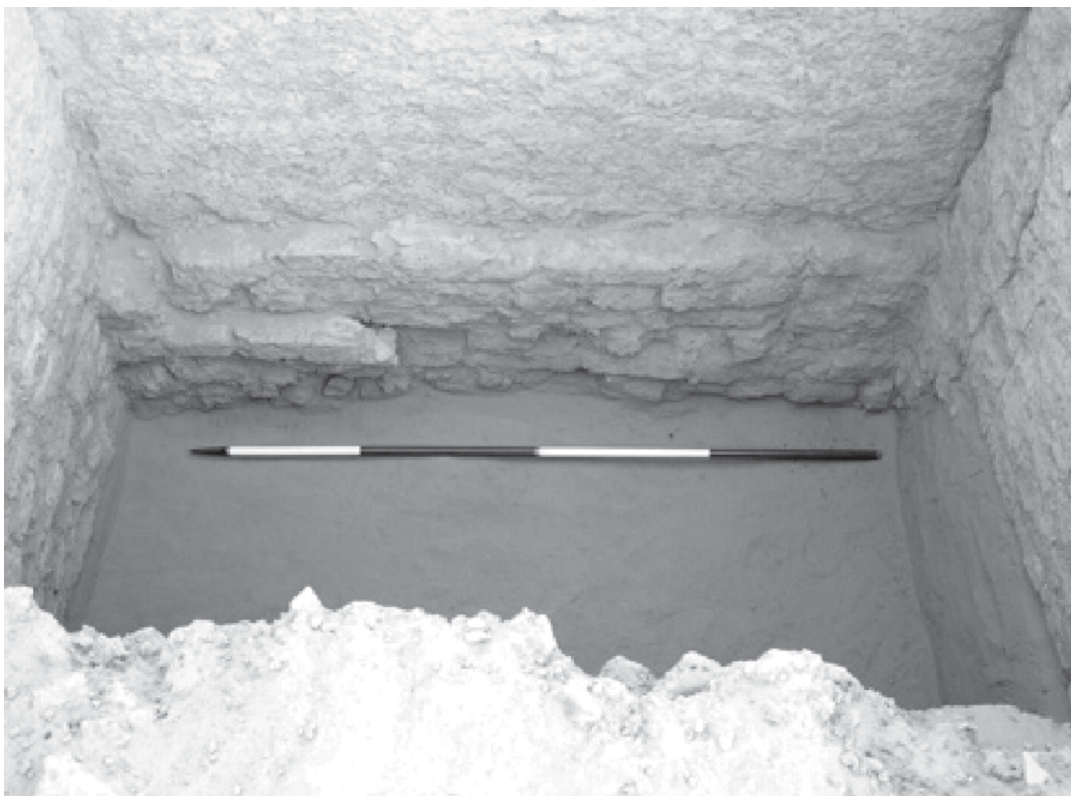
Plate 16 Trench 6, showing the north and west walls of the tower and the low internal wall on the right looking north; © C. A. Hope.

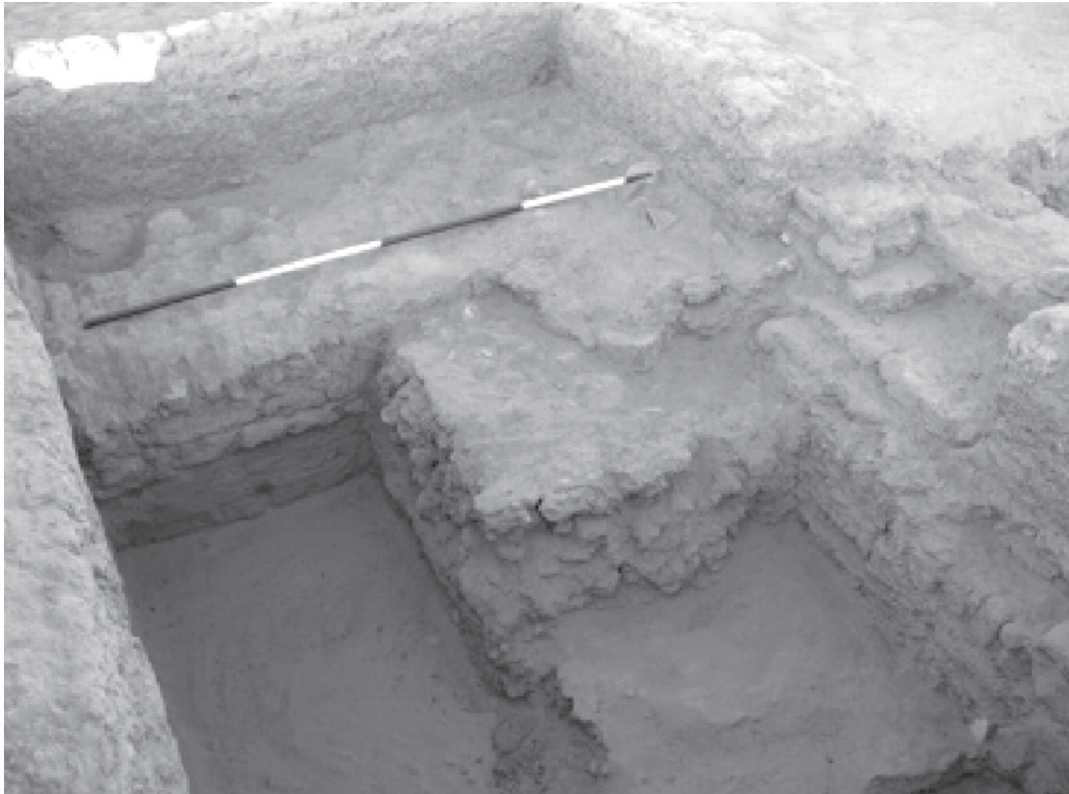
Plate 17 Trench 10, showing the low walls on the sand foundation, the rubble fill and the late walls looking north-west; © C. A. Hope.

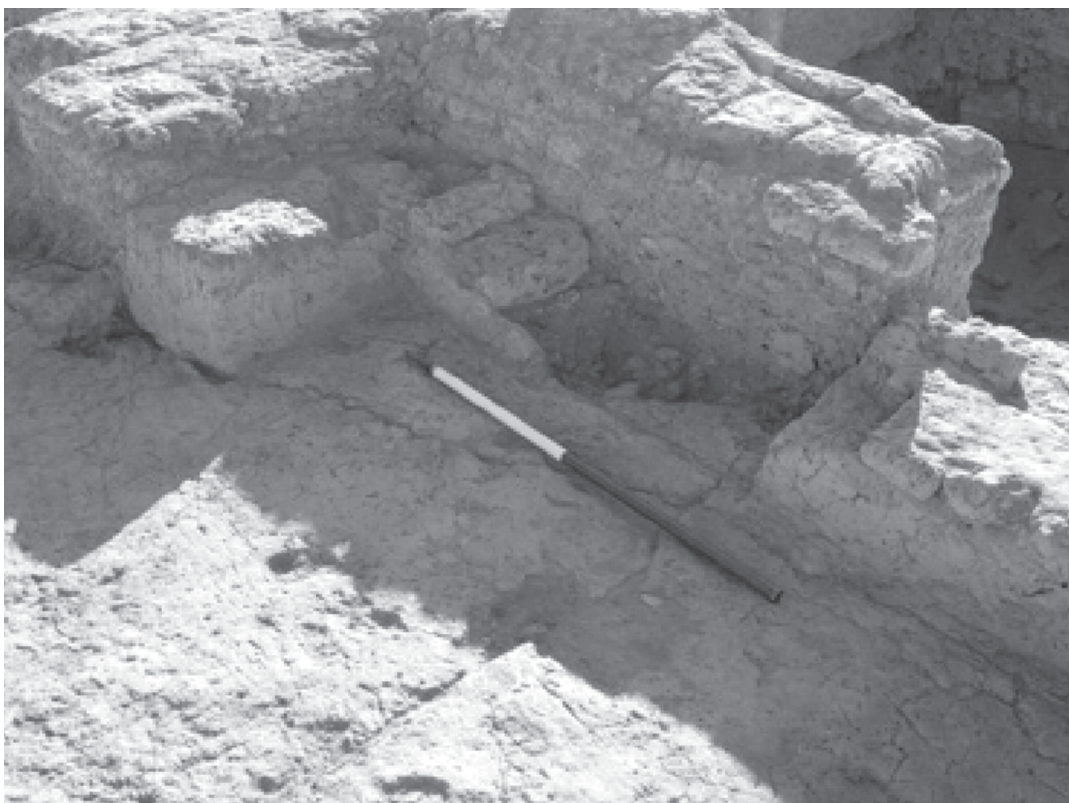
Plate 18 Trenches 11 and 12, showing the south-east corner of the corridor with the mud floor, the mastaba and the wall and doorway into the south-east room looking south-east; © C. A. Hope.

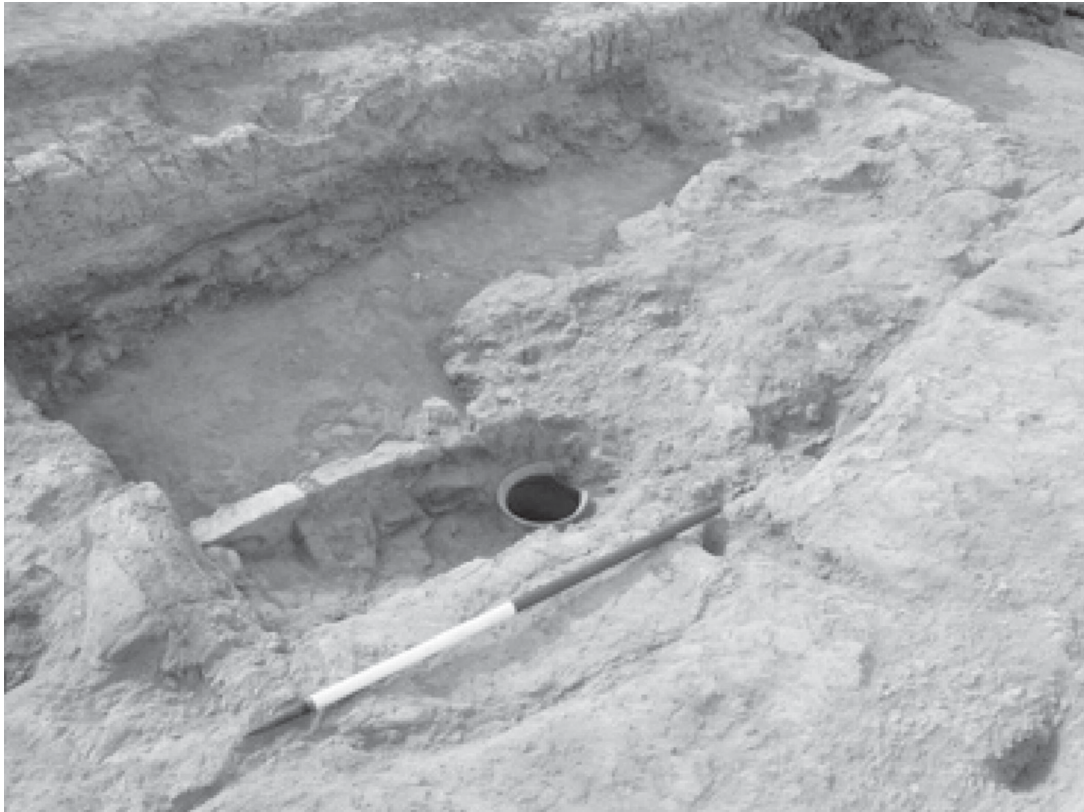
Plate 19 Trench 12, the corridor with the hearth and cooking pot looking south-west; © C. A. Hope.

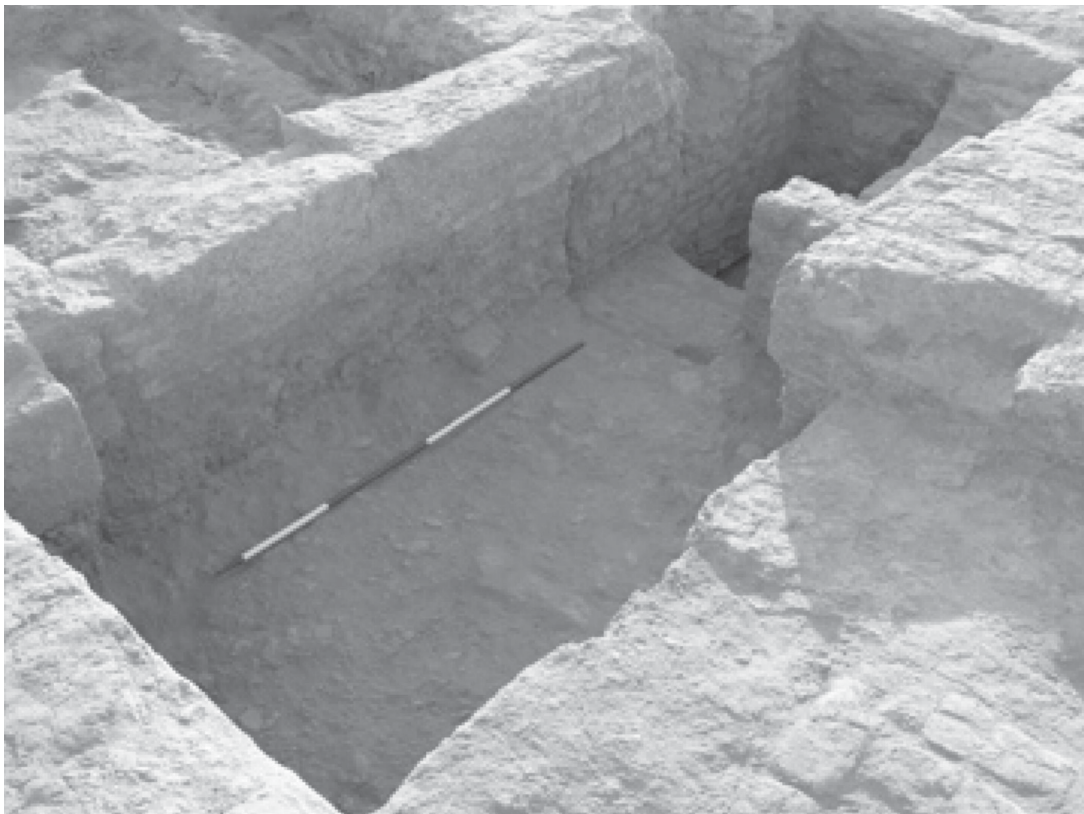
Plate 20 Trench 5, the eastern extension showing the lower and upper walls and the blocked doorway in the south visible in the upper left, looking south-east; © C. A. Hope.

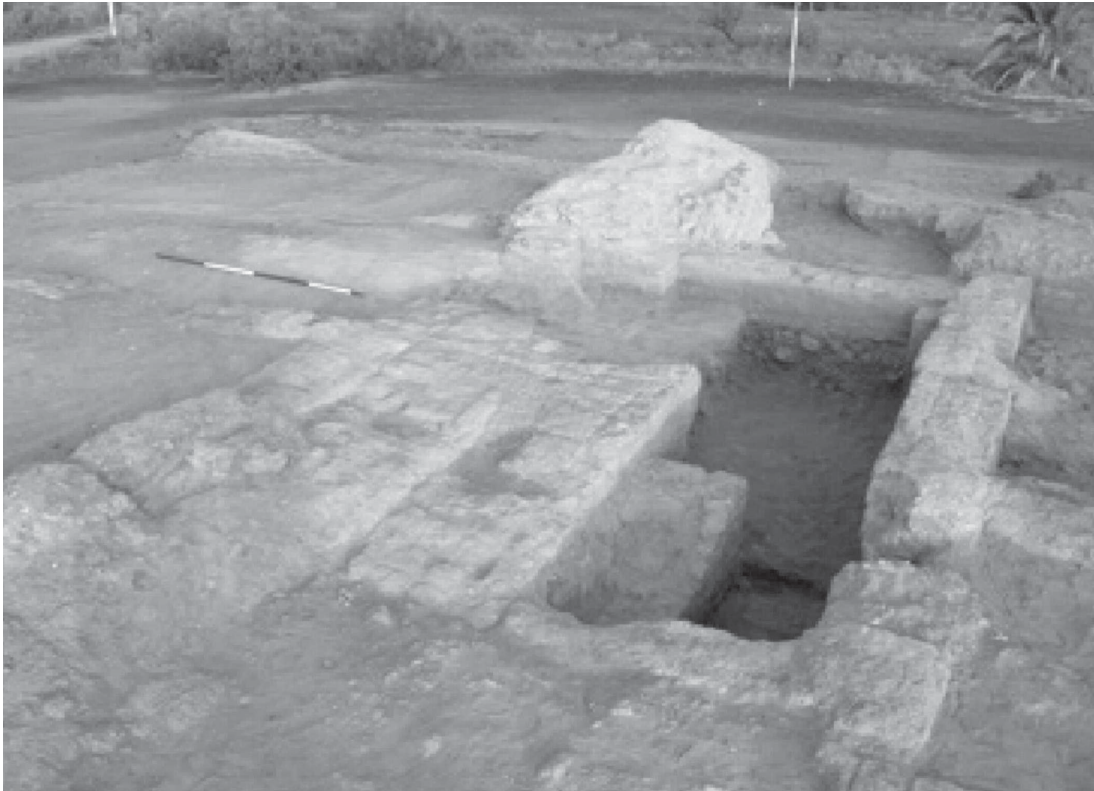
*Plate 21 Trench 5, the west section of the eastern extension with the tower on the right, looking north-west;
© C. A. Hope.*

The initial focus was the area to the immediate east of the tower, Trench 5, which was excavated in the 2009 season. This is a roughly L-shaped area 5.4 metres north-south by 3.6 metres, narrowing to 1.4 metres east-west. Two construction phases were identified. A test was cut in the southern part of the trench, where an intrusive pit indicated the presence of earlier structures; this revealed two early north-south brown mud brick walls, 0.7 metres apart and the top of either an east-west wall, or a brick platform, which abutted the other walls in the north (Plate 20). A mud floor associated with these walls was laid directly onto a sand foundation, as were the low walls. The walls were cut down and a rubble fill deposited for the next construction phase. The south wall of Trench 5 was laid above these walls and the east wall was laid atop the lower east wall. No sub-floor excavation was undertaken in the north of Trench 5 and so we were not able to determine whether there are earlier structures in this area. The second building phase is contemporary with the final phase within the tower, with which it communicates via an entrance-way 1.16 metres wide. The same compact, dense clay floor of the corridor is continued through the doorway and into Trench 5. The area to the immediate east of the entrance to the tower is brick paved and may once have served as a courtyard. Two doorways located in the eastern wall gave access to the rooms beyond: Trenches 16 and 17. Both doorways had been blocked: the northern one with bricks and mortar, and that to the south was blocked by rubble that appears to have been deliberately laid. As with the tower, the walls associated with the last building in the eastern extension are badly deflated and are preserved to a similar height (Plate 21).

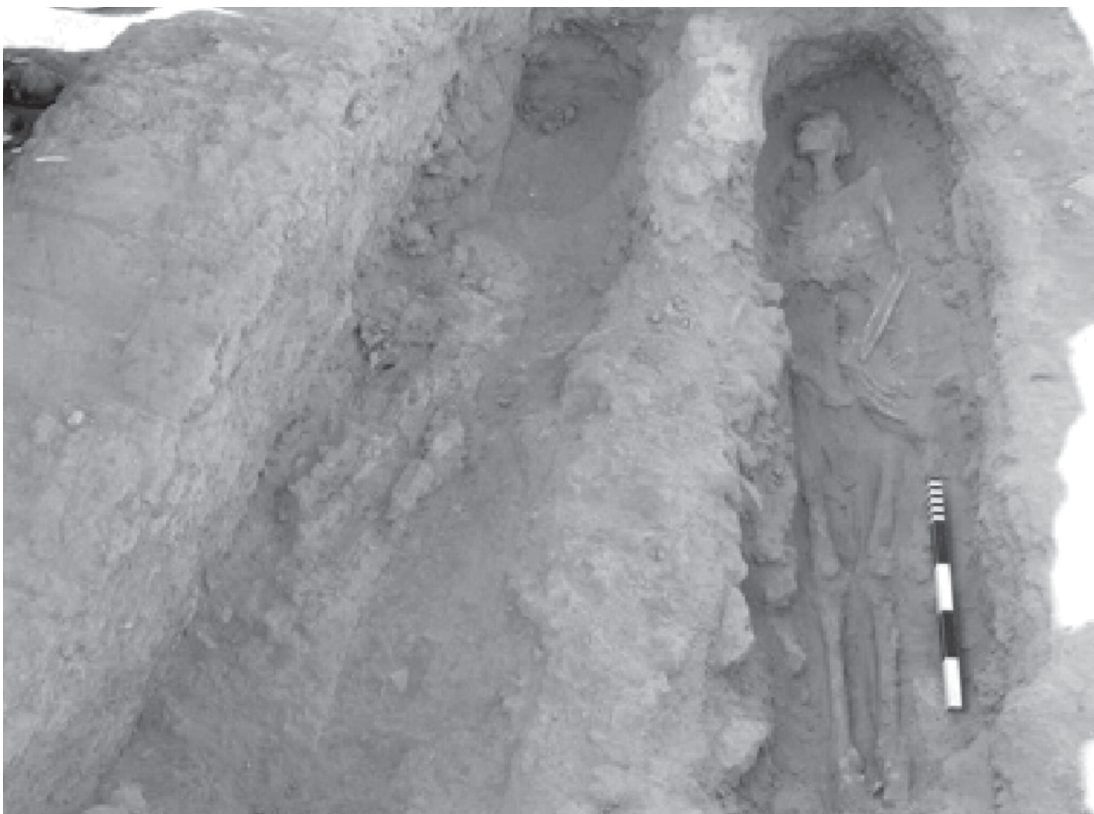
*Plate 22 Trench 17 (formerly part of Trench 5), eastern extension showing two intrusive graves cut into the room
with the dividing wall on the left, looking west; © C. A. Hope.*

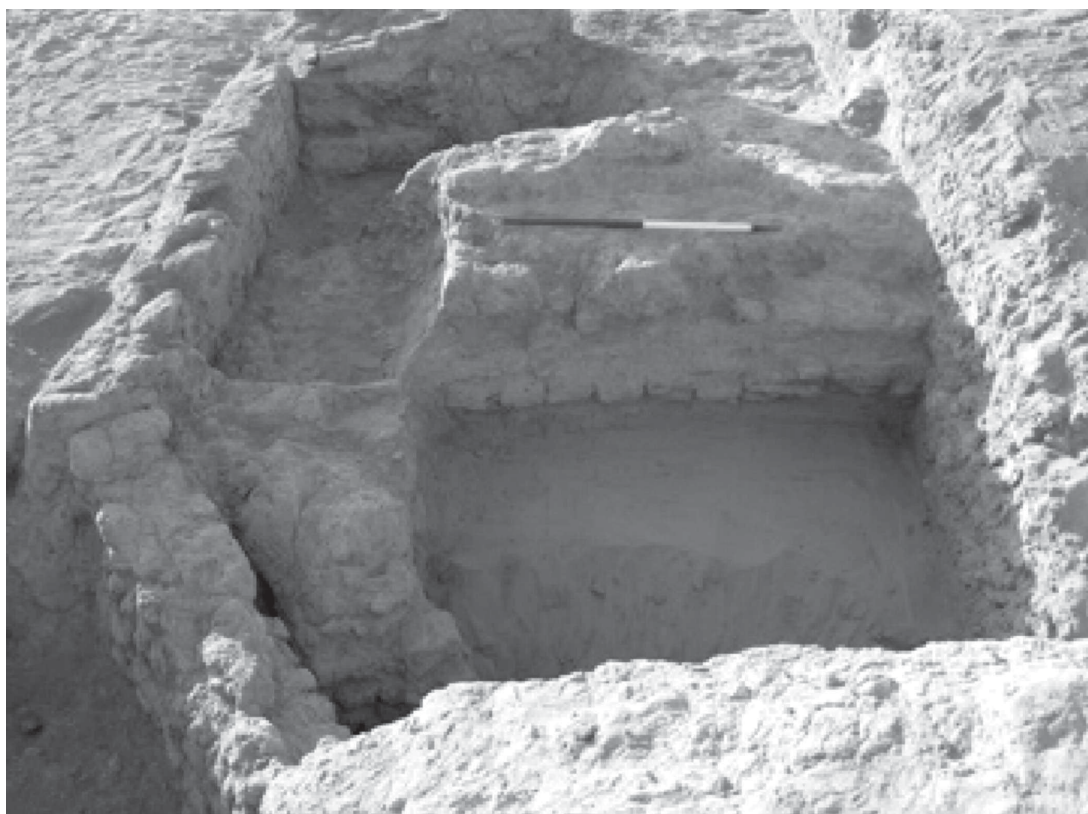
Plate 23 Trench 7, showing the basins looking south; © C. A. Hope.

which had been modified over a period of time. The west buildings and the church were already in place when construction began in this area (Plate 23). The trench was extended to the north-east to the entrance of the passageway between the church and the west buildings to determine their temporal relationship. This test was extended to the north in 2011 (Trench 13) at which time we were able to demonstrate that the church and the eastern extension of the west buildings were built on the same horizon and are contemporary. This was shown by a well-preserved, mud-plastered floor laid above the sand extending against and up the walls of both structures (Plate 24). A narrow east-west wall at the north end of the passageway might be a late insertion and this area awaits further study.

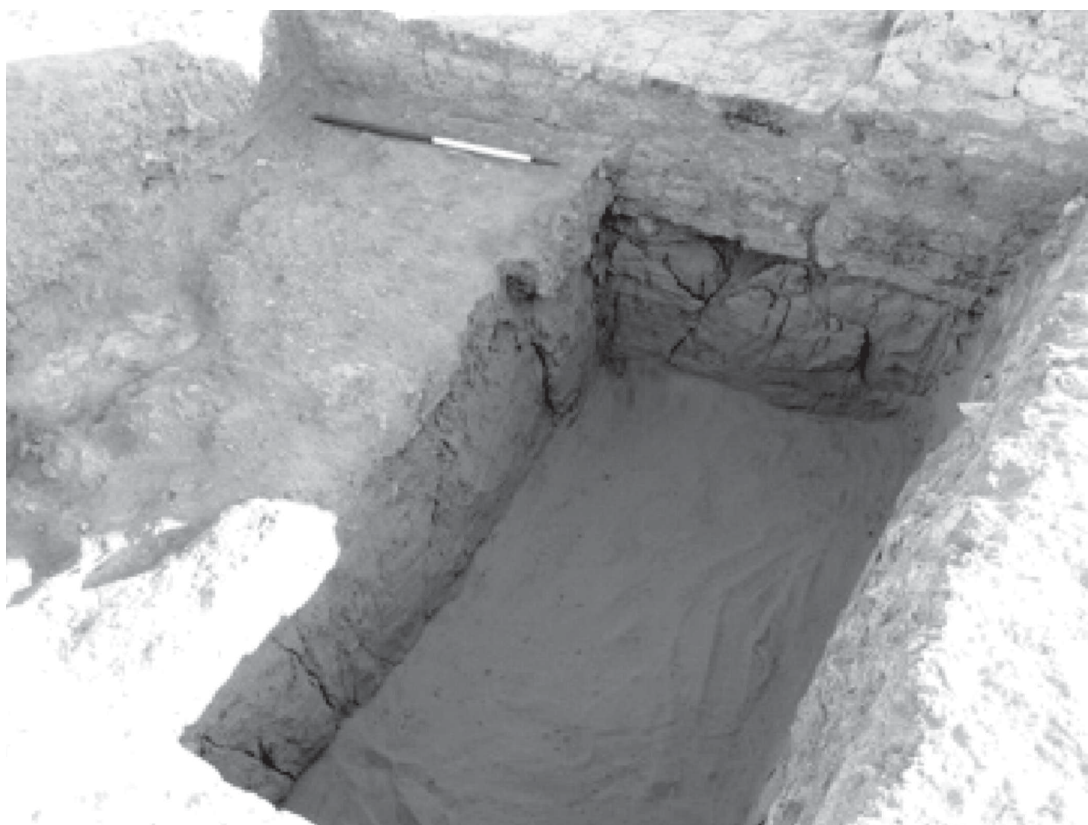
Plate 24 Trench 13, the passageway between the church and the west buildings showing the foundation of the west wall of the church, looking north-east; © C. A. Hope.

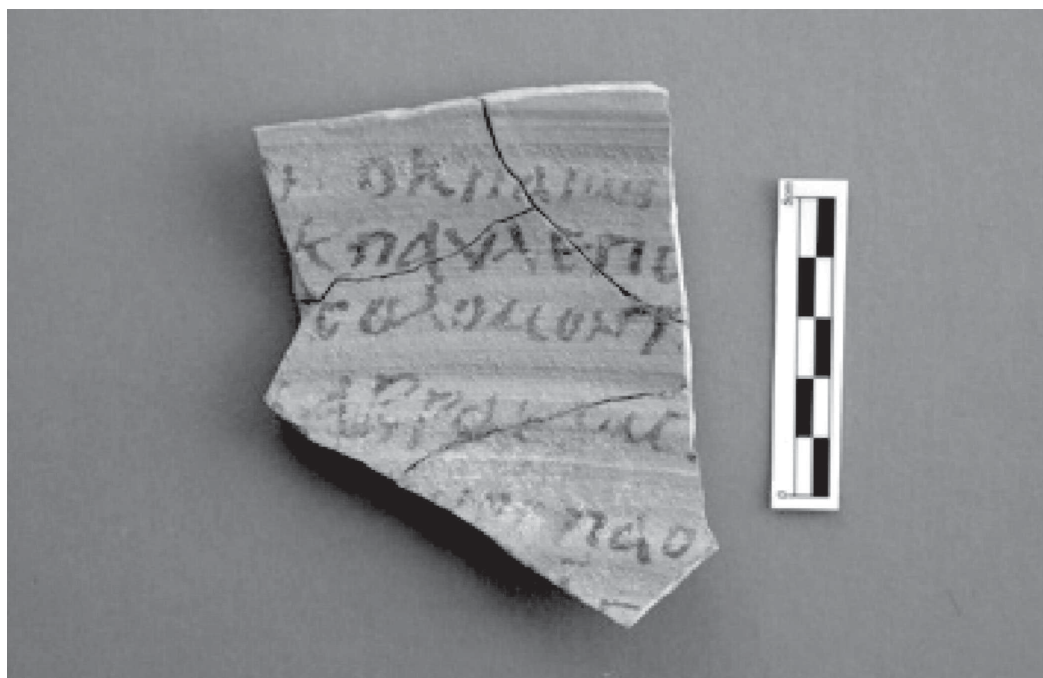
Plate 25 A Coptic ostrakon retrieved from Trench 12; © C. A. Hope.

In total 21 Coptic ostraka were found in the tower. The majority were retrieved from the corridor some in association with the hearth. A further seven were found in the eastern extension. They all await study but Iain Gardner notes that those found in 2011 are written in Sahidic dialect and can be dated from the latter part of the 4th century and through the 5th (Plate 25). Several preserve names which include Solomon, Abraham, Alexandros, Apa Iakob and Apa Paulos. The ceramic assemblage from the early phase within the west buildings dates to the 4th and 5th centuries; that from the modification phases dates from the 5th to 6th centuries. The basins south of the eastern extension are of the same period although a few sherds belonging to 7th-century vessels were recovered.
